A Field Investigation of Glacial Lake Outburst Potential in the Taiya River Watershed, Skagway, Alaska

Chuck Denton, Larry Standley, and Brent Lewis

BLM-Alaska Open File Report 99
June 2005

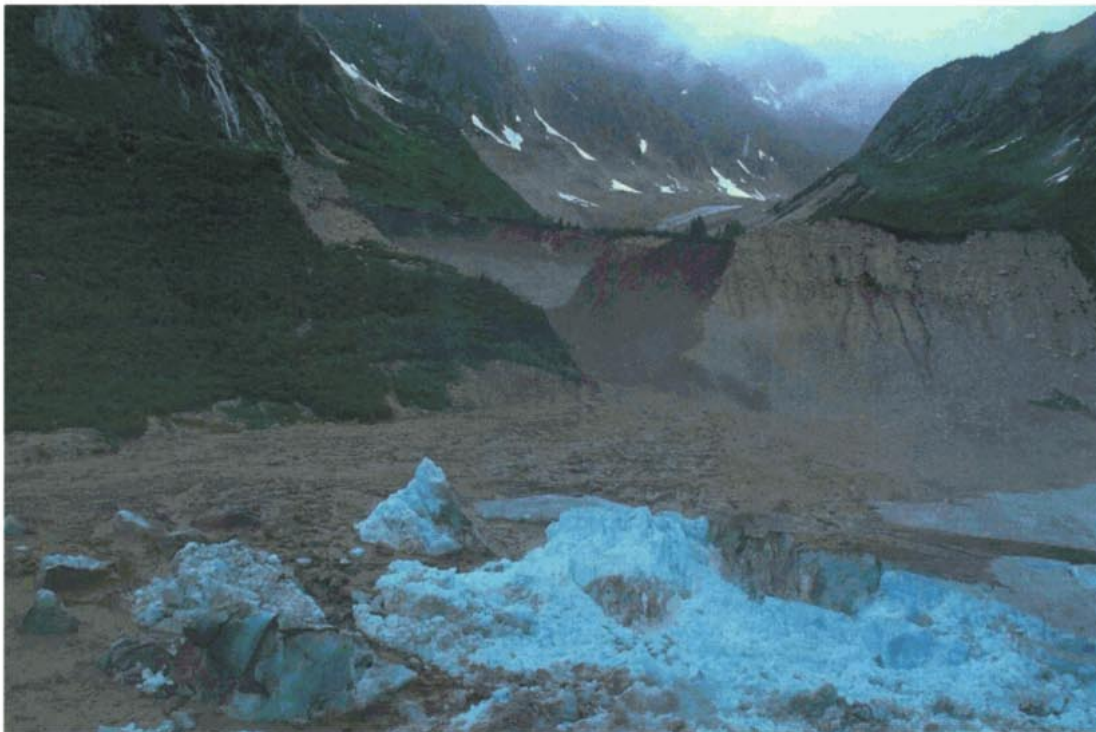
A lateral moraine of West Creek Glacier in the Taiya River watershed near Skagway, Alaska, liquefied in July 2002, causing debris to slide into a glacial lake in front of the glacier's terminus. This event triggered a tremendous flood at Klondike Gold Rush National Historic Park and the community of Dyea, causing extensive damage to bridges, roads and private property. Photos courtesy TEMSCO Helicopters.

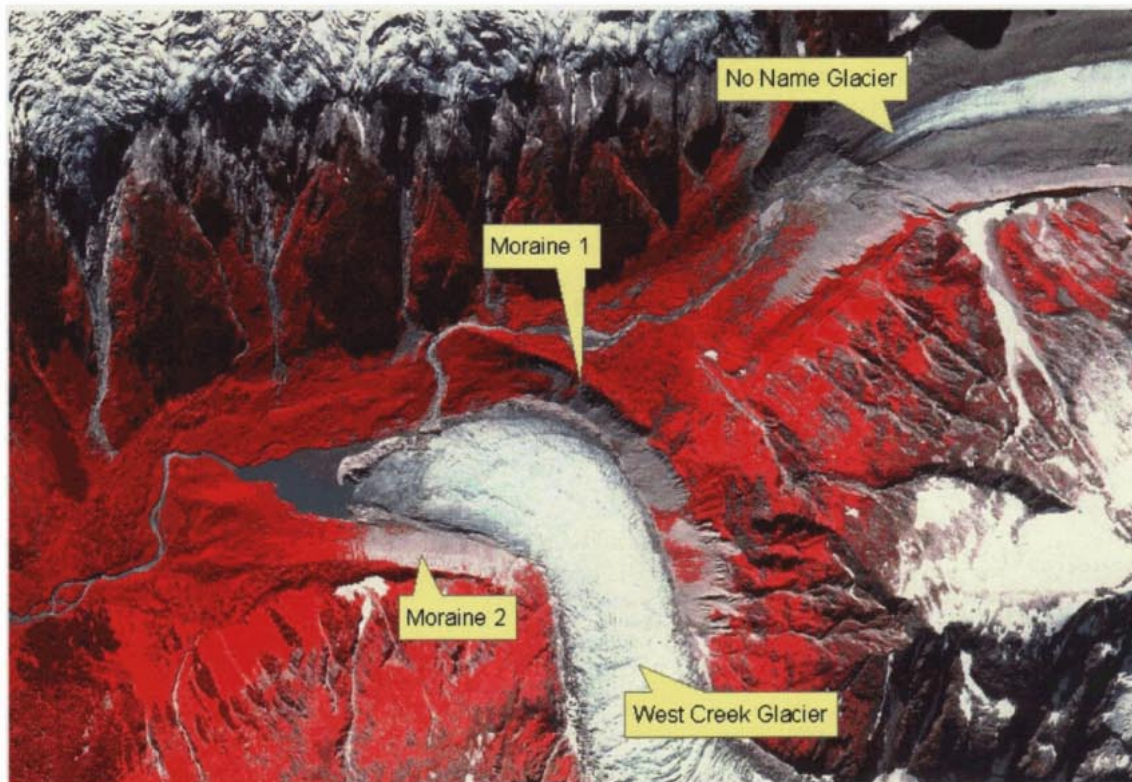
The 2002 glacial lake outwash event was created by the collapse of Moraine 1 (Figure 2). Moraine 1 is a lateral moraine to the West Creek Glacier that formed perpendicular to the No Name glacier river valley (Figure 2). This configuration created a structure composed of glaciated (fine) material with steep side slopes that were disproportional to its relative height. As the No Name Glacier receded, the area behind the moraine filled in with very fine sediment. This soil class characteristically has a considerable pore space volume, which results in its ability to retain large volumes of water as compared to coarse-textured soils (Miller, 1990). It is also more susceptible to erosional forces due to its small particle size (Miller, 1990). The relatively fine sediment of this moraine was subject to saturation from drainage coming from the No Name valley. Steep, wet and fine sediments created a high potential for slope stability failure.

Dave Herbig of TEMSCO Helicopters reported observing water and debris spewing from the base of the moraine the day prior to its collapse. There is no available information concerning the structural integrity of the moraine before the 2002 event. Considering the characteristics of the fine material that composed the moraine, the annual precipitation of the area, and the witnessed account of the events prior to the collapse, we hypothesized that water drained through the moraine creating a preferential flow path. This path may have resulted in seepage of water at the base of the moraine. As the flow of water through the moraine increased incrementally, this may have resulted in the increased removal of erosive moraine material. This process resulted in the extreme preferential flow path of water and debris that discharged at the base of the moraine.

The removal of material created a sinkhole which resulted in further instability and the catastrophic release of debris into the West Creek glacial lake displacing water into West Creek. This caused a majority of the lake to fill in with debris, which rapidly displaced water into West Creek, and greatly diminished the lake's current holding capacity.

An inspection of lateral Moraine 2 (Figure 2) adjacent to the West Creek Glacial Lakes identifies a different situation compared to that of Moraine 1. Moraine 2 is approximately 520 ft (158 m) high, 150 ft (46 m) thick at the base and 50 ft (15 m) thick at the top. The majority of the moraine has a slope of 35 percent with the top 50 ft (15 m) having 60 percent slope. Moraine 2 is composed of multiple size class sediments which have been pushed against the rocky slope of a mountain side. This rocky slope provides structural support to the underside of the moraine which may prevent a catastrophic collapse similar to that which occurred at Moraine 1. In addition, the location of Moraine 2 makes it much less subject to constant saturation as was the case for Moraine 1. It was evident from the size and composition of the toe of the slope that material from the steeper sections has been sloughing off over time. This is likely to continue until a stable angle of repose is reached.

Figure 2. Infrared aerial photo of the West Creek Glacier area, August 1979.

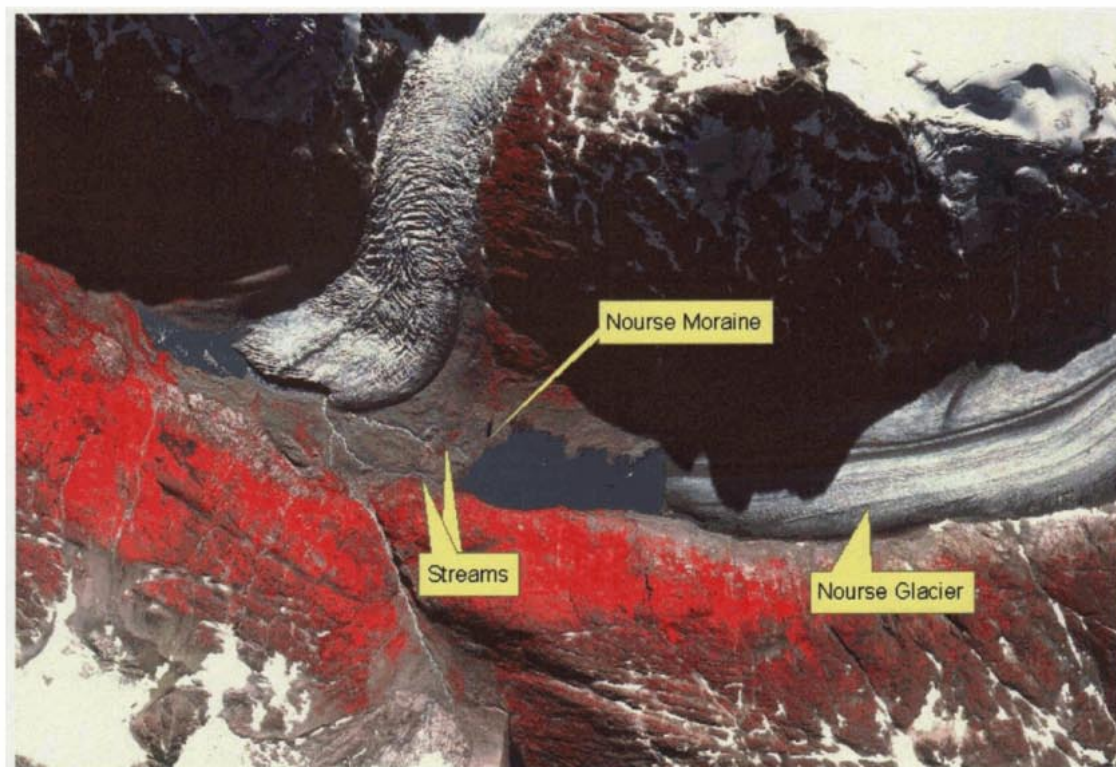
The surface of the Nourse moraine is composed of multiple size class sediments including large boulders, cobble and sand. The Nourse moraine has a measured length of 2,640 ft (804 m), an average slope of 15 percent, and a calculated height of 396 ft (120 m), confirming Capps (2004) measurements. Two streams have formed that allow water to flow over the moraine (Figure 3). These streams appear to be well armored by small boulders and cobble. Observations revealed no areas of excessive sagging or sloughing.

Typically, moraines such as that found at the Nourse Glacier are held together by the presence of an ice core (Souchez, R.A., 1971, Reynolds, 1998, Moorman, et al.2000). As average annual temperatures increase, these ice cores become susceptible to degradation. A failure may occur when the moraine structure becomes too weak to hold back the force created by the large volume of water trapped behind the moraine.

The malfunction of the EM equipment prevented a subsurface inspection of the Nourse moraine. The composition and surface slope (15 percent) of this moraine does not indicate a high potential for instability or failure. However, the large volume of water trapped behind this moraine has the potential to cause significant downstream damage if catastrophically released. According to Hal Pranger (geomorphologist, National Park Service), seven different dam failure equations were used to estimate peak discharge in the event of a catastrophic moraine failure. All seven equations estimate an at-the-moraine discharge in the 250,000 (cfs) range. Five equations estimate the peak discharge at Dyea to be in excess of five times the estimated 500-year flood event on the Taiya River.

Figure 3. Infrared aerial photo of the Nourse Glacier area, August 1979.

The overall integrity of the Nourse moraine should be determined in order to provide improved information concerning geohazards on public lands. It remains extremely important to fully understand the subsurface structural integrity of this moraine, and specifically the presence or absence of an ice core, in order to more accurately predict hazard potential.

This information may assist downstream land managers in deciding the best course of action to mitigate damages caused by flooding. These inspections should include a surface inspection to identify any seepage locations and rates and an evaluation of the internal composition and integrity of the moraine through the use of geophysical instrumentation.
